NOISE LAB
TEST REPORT Number A-2025LAB-015-L054-45832_E

Tests : Laboratory measurement of the improvement of impact sound insulation by a floor covering on a heavyweight standard floor.
Product name : CircoFloor 200 mm (5P) - Recycork 9 mm - OSB 18 mm

CircoFloor 200 mm (5P) - Recycork 9 mm - OSB 18 mm

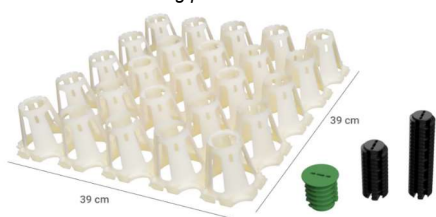
structural interlocking panel 39 cm x 39 cm

Composed of cup-shaped panels interlocked in opposing orientations, forming a single structural panel with a total height of 88 mm.

Material: Polypropylene (PP)

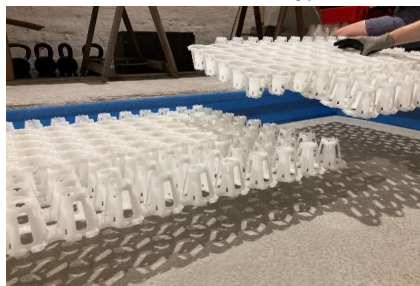
Installation of the CircoFloor interlocking panels

The assembly was carried out by the manufacturer, Staenis, fully in accordance with the manufacturer's instructions.
 The correct height of the CircoFloor system was set using a line laser and a reference point to ensure proper adjustment.
 The laboratory verified whether the specified floor build-up height was correctly applied.
 The floor was classified according to annex H.2.2, ISO 10140-1: Category II - Large specimen.
 This category includes floor coverings of which at least one constituent is rigid.
 The floorcovering measures $\pm 3.0\text{m} \times 4.0\text{m}$ and covers at least 10m^2 with a smaller dimension of at least 2.3m .
 The tapping machine was placed in 4 different positions on the test floor.
 The same tapping machine positions were used on the uncovered concrete reference floor.

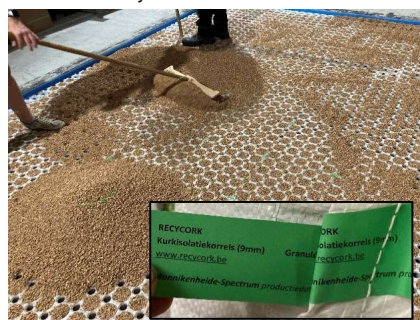
Type: Granular insulation material composed of recycled cork.

Granule size: 0.5 mm – 9 mm.

Infill material: Recycork 9 mm

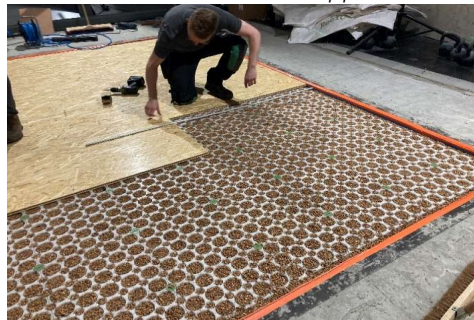
Type: AGEPAN OSB 3 Ecoboard (mechanically fixed to the CircoFloor system using ≈ 13 screws/ m²)

Installation of the 18 mm OSB top panels
