**NOISE LAB**  
**TEST REPORT Number A-2025LAB-015-L058-45832\_E**

**Tests :** Laboratory measurement of the improvement of impact sound insulation by a floor covering on a heavyweight standard floor.  
**Product name :** CircoFloor 140 mm (4P) - Recycork 9 mm - OSB 18 mm

**NOISE LAB**  
**TEST REPORT Number      A-2025LAB-015-L058-45832\_E**

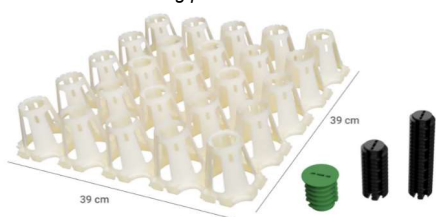
structural interlocking panel 39 cm x 39 cm

Composed of cup-shaped panels interlocked in opposing orientations, forming a single structural panel with a total height of 88 mm.

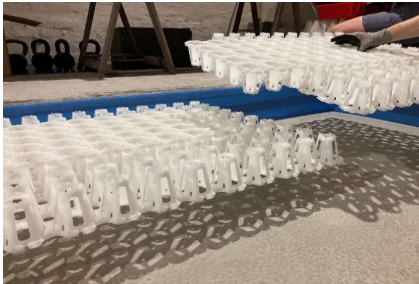
Installation of the CircoFloor interlocking panels

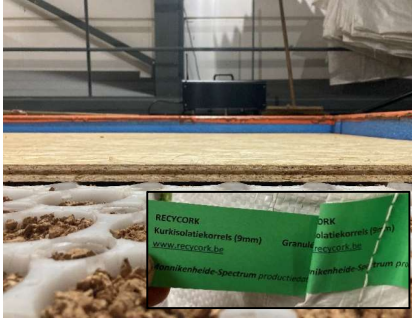
Infill material: Recycork 9 mm

Infill material: Recycork 9 mm

Type: Granular insulation material composed of recycled cork.
