**NOISE LAB**  
**TEST REPORT Number A-2025LAB-015-L063-45832\_E**

**Tests :** Laboratory measurement of the improvement of impact sound insulation by a floor covering on a heavyweight standard floor.  
**Product name :** CircoFloor 140 mm (4P) on Vilton V22 felt pads (5mm) - Recycork 9 mm - OSB 18 mm

**TEST REPORT Number A-2025LAB-015-L063-45832\_E**

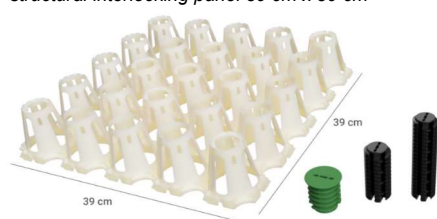
Composed of cup-shaped panels interlocked in opposing orientations, forming a single structural panel with a total height of 88 mm.

The supports are arranged in a 4-point support configuration, positioned at the square intersections (39 cm c/c).

structural interlocking panel 39 cm x 39 cm

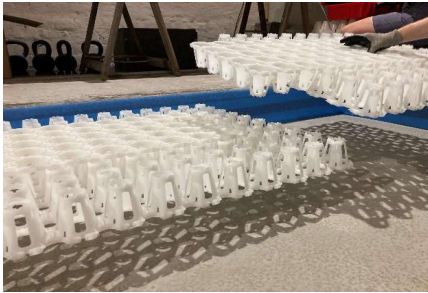
Installation of the CircoFloor interlocking panels

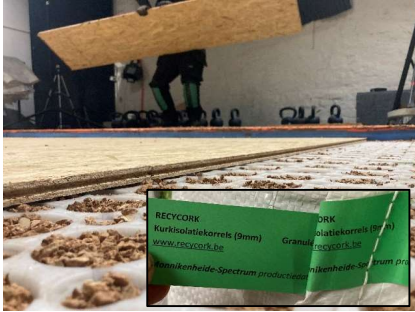
Infill material: Recycork 9 mm

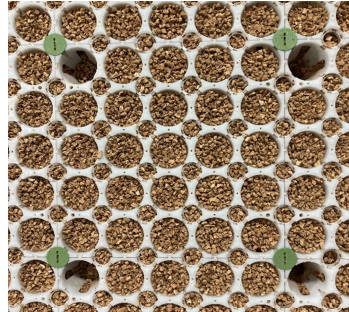
4-point support configuration

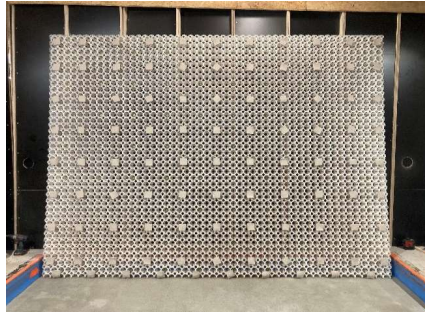
Backside of the full CircoFloor structure (12m²) with 98 supports + pads
