**NOISE LAB**  
**TEST REPORT Number A-2025LAB-015-L064-45834\_E**

**Tests :** Laboratory measurement of the improvement of impact sound insulation by a floor covering on a heavyweight standard floor.  
**Product name :** CircoFloor 140 mm (4P) - Pearls Graphite EPS - OSB 18 mm  
 Renewworks

**CircoFloor 140 mm (4P) - Pearls Graphite EPS - OSB 18 mm**

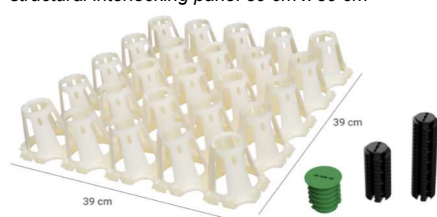
Composed of cup-shaped panels interlocked in opposing orientations, forming a single structural panel with a total height of 88 mm.

The supports are arranged in a 4-point support configuration, positioned at the square intersections (39 cm c/c).

structural interlocking panel 39 cm x 39 cm

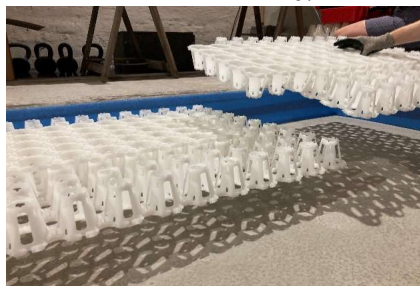
*Installation of the CircoFloor interlocking panels*

The assembly was carried out by the manufacturer, Staenis, fully in accordance with the manufacturer's instructions.  
 The correct height of the CircoFloor system was set using a line laser and a reference point to ensure proper adjustment.  
 The laboratory verified whether the specified floor build-up height was correctly applied.  
 The floor was classified according to annex H.2.2, ISO 10140-1: Category II - Large specimen.  
 This category includes floor coverings of which at least one constituent is rigid.  
 The floorcovering measures  $\pm 3.0\text{m} \times 4.0\text{m}$  and covers at least  $10\text{m}^2$  with a smaller dimension of at least  $2.3\text{m}$ .  
 The tapping machine was placed in 4 different positions on the test floor.  
 The same tapping machine positions were used on the uncovered concrete reference floor.

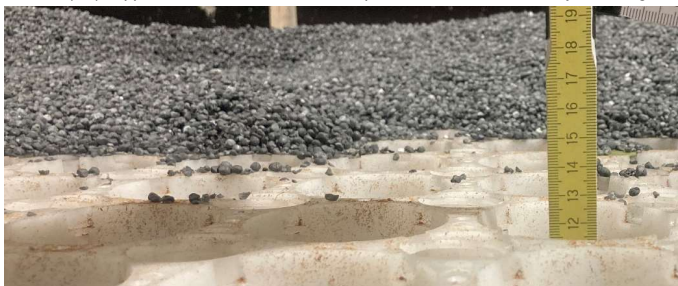
*87 mm (PP) supports screwed in the structural panels, to achieve a total system height of 122 mm + (18 mm OSB)*

The CircoFloor system was leveled using the 87 mm height-adjustable (PP) supports ø28 mm,

screwed in the structural panels, to achieve a total system height of 122 mm.

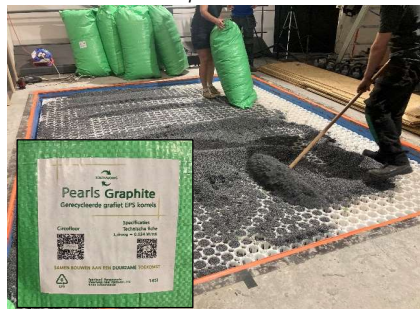
*Infill material: Pearls Graphite EPS Renewworks*

Infill material: Pearls Graphite EPS Renewworks

Type: Graphite recycled EPS beads

Pearl diameter: ± 5 mm

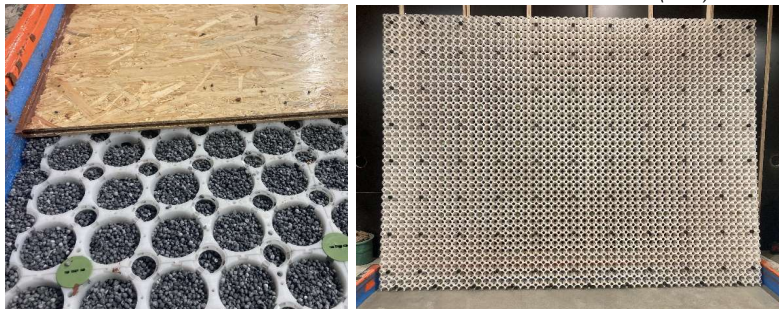
*Backside of the full CircoFloor structure (12m²) with 98 supports*

Total contact point connections with the test floor (3000 mm x 4000 mm): 98

This corresponds to 88 primary support points at the square intersections (≈7 supports/m<sup>2</sup>)

plus 10 additional supports along one longitudinal side of the test floor to provide extra support on that side.

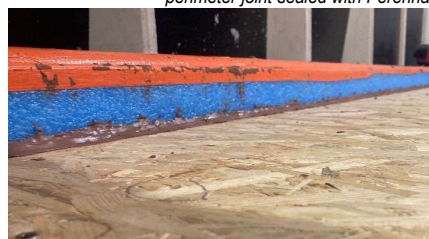
*perimeter joint sealed with Perennator*

A flexible sealant (Perennator) was used to seal the perimeter joint (±5 mm) between the 18 mm OSB top plate and the surrounding structure.
